TECHNICAL REPORT 84-4

WEARING SURFACES FOR STEEL ORTHOTROPIC BRIDGE DECKS

JUNE, 1984

FIRST INTERIM REPORT

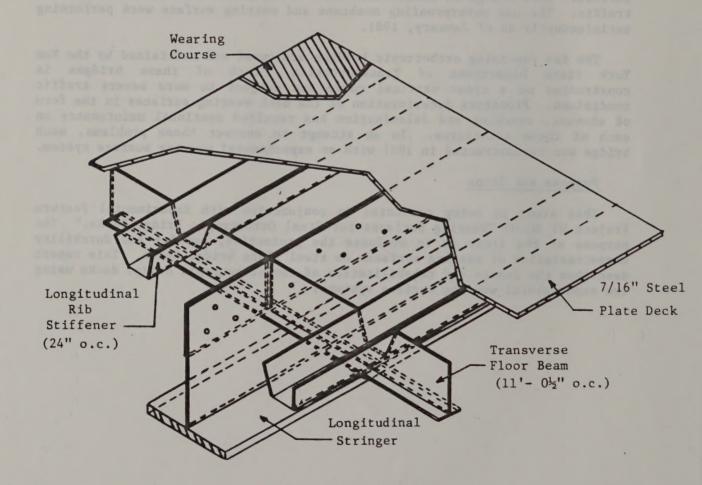
FIGURE 1 - ORTHOTROPIC STEEL DECK PLATE DESIGN
WHITEHALL TEST SITE (SOUTH BAY BRIDGE)

This structure is located on NY Route 22, north of Whitehall, over the South Bay of Lake Champlain. The original bridge was built in 1973 on a crest vertical curve, connected by 2% grades. The structure is 530 feet long by 42 feet wide and consists of six - 88'4" long simple spans. The original design specified 7/16" thick steel deck plates, stiffened in two mutually perpendicular directions by a system of longitudinal and transverse ribs welded to them. Abutting prefabricated deck sections were bolted together. On the South Bay Bridge, the longitudinal stiffeners consisted of closed ribs of a trapezoidal cross section spaced on 24" centers; transverse stiffeners, spaced on 11'0½" centers, consisted of floor beams which used the steel deck as their top flange. Figure 1 is a schematic of this orthotropic design.

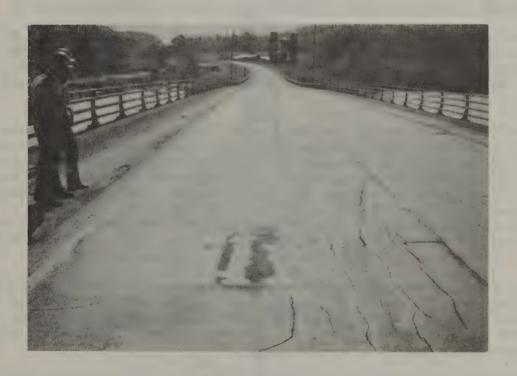
Within one year of completion, cracking in the wearing surface and underlying protective coating occurred. These defects were primarily located over the longitudinal joints formed by abutting steel deck plates. Excess flexibility, due to the lack of adequate load distribution between the bolted deck sections was thought to create this condition. The resultant cracking permitted the entry of moisture to the steel plate deck causing some minor corrosion and promoting large scale deterioration of the wearing surface. Figure 2 shows the condition of the wearing surface prior to reconstruction.

Figure 2. Deteriorated Deck at South Bay Before Reconstruction.

In 1981, the South Bay Bridge was reconstructed under Contract No. D96636, P.I.N. 1130.27.321, F.A. Project No. FR-73 (102). This work consisted of removing the existing wearing surface; stiffening the steel deck plates to reduce flexibility; and placing an experimental wearing surface system. Stiffening was accomplished by adding angles between the transverse stiffeners and the longitudinal stringers, and by welding the longitudinal joints between abutting deck panels. The new wearing system consisted of coating the steel deck with an inorganic zinc-rich silicate paint for corrosion protection; the application of an asphalt emulsion tack coat; a first course paving $(1-l\frac{1}{2})$ inch thick) of asphalt concrete; the application of a proprietary fabric membrane for waterproofing and crack control; and paving a second course wearing surface of asphalt concrete $(1-l\frac{1}{2})$ inch thick). The proprietary membrane in this system was "Petromat fabric" (5 oz/s.y.), Bridge Deck Membrane Grade, as manufactured by Phillips Fibers Corporation, Greenville, South Carolina.

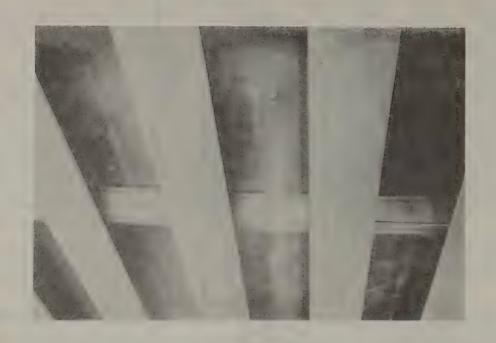
Figure 4. Underside of Webster Street Bridge.

The orthotropic design of the Webster Street Bridge is different from that of South Bay. The individual 3/4 inch deck plates are connected by a bolted splice plate on the underside and welded together on the topside. Heavy transverse floor beams, spaced 2'-9" on center are welded to the deck plates that in turn act as the upper flange. Longitudinal diaphragms (stiffeners) consist of W8 x 17 beams spaced 8'-6" on center. These diaphragms are bolted to the web of the transverse floor beams. This design provides a steel deck that is significantly more rigid than that at South Bay. Figure 4 shows the underside construction of the Webster Street Bridge.

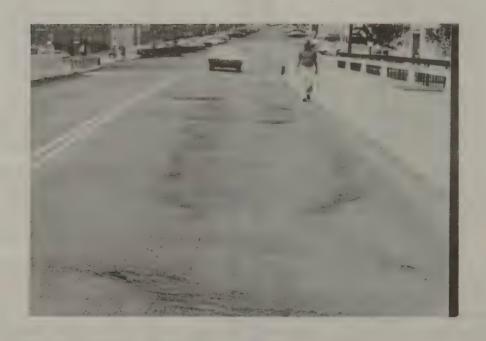
Failure occurred with this system within one year of completion primarily in the form of shoving on the 3.8% grade. Cores taken from the wearing surface indicated two failure modes. The asphalt was sliding directly over the top of the bituminous epoxy membrane and the epoxy membrane was delaminating between the first and second coats. In this latter case the two applications of epoxy, which were placed in cool weather, had failed to completely cure, resulting in slippage (shear) at their interface. Figure 5 shows the condition of the wearing surface prior to reconstruction.

Figure 5. Pavement Shoving on Webster Street Bridge Before Reconstruction.

The Webster Street Bridge was rehabilitated in 1981 under Contract No. D96775, P.I.N. 5940.03.303. Work consisted of removing the existing asphalt wearing surface and bituminous epoxy membrane and replacing it with an experimental wearing course system. This new system consisted of applying a proprietary preformed sheet waterproofing membrane and paving a 2 inch thick asphalt wearing surface. The proprietary membrane in this system was "Bituthene 5000" (formerly "Heavy Duty Bituthene"), as manufactured by W.R. Grace and Co., Cambridge, MA.

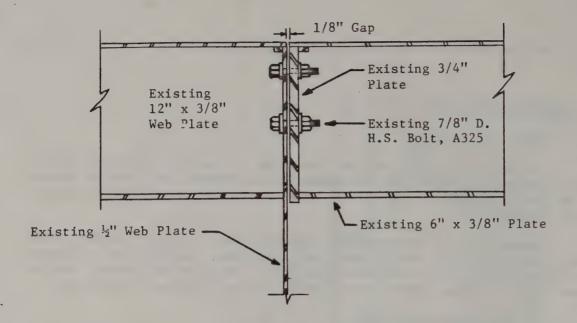
FIGURE 7 - TRANSVERSE DETAIL BEFORE STIFFENING

To stiffen the deck and obtain continuity between abutting steel plates, stiffening angles were bolted and welded to the underside, at the location where each transverse floor beam intersected an interior girder. In addition, the longitudinal joints formed by adjoining steel deck plates were continuously welded. Originally, these sections were joined only by bolting through the web of each interior girder (Figure 7).

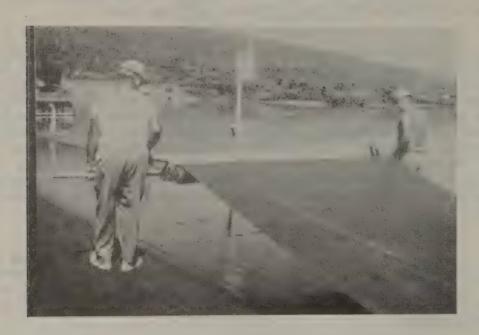
Figure 9. Manual Application of Fabric Membrane.

Application began by spraying a 310°F asphalt cement (AC-20) at the rate of .25 gal./sq. yd. On the advice of "Petromat's" technical representative, this rate was increased to .30 gal./sq. yd. application was performed manually (Figure 9) with the aid of push brooms to provide tension in the roll and to smooth out any wrinkles. To provide transverse drainage, longitudinal overlaps were shingled 6 to 12 inches; transverse overlaps were positioned to prevent pick-up by the paving equipment. The only problem encountered during this operation occurred during the second stage of rehabilitation in October. Cool weather conditions (50-55°F) prevented distributor truck spray application of the asphalt cement binder. Normally the distributor truck would spray binder one span (88 ft.) ahead of the membrane placement operation. In the cool weather the asphalt cement hardened prematurely, resulting in a tack-free surface which the "Petromat" could not absorb or adhere to. The ensuing hand spraying, only 10 to 15 feet ahead, left a tackier substrate for the membrane to be placed. This method was effective, but tended to create a heavy and non-uniform binder application.

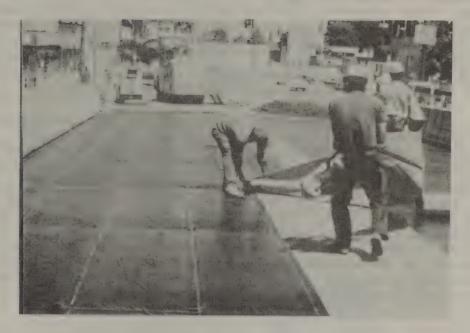
Figure 10. Membrane Waterproofing Application.

Membrane application started at each curb section (low point) and progressed toward the roadway centerline (Figure 10). This method provided a "shingling" effect for transverse water drainage. Longitudinal overlaps were 2 inches; transverse overlaps were 8 inches and also "shingled" to provide down-grade water run off. The membrane application was completed in two days (Figure 11).

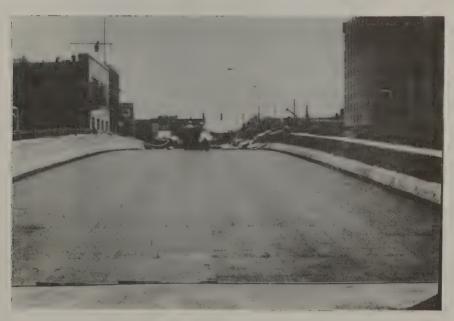
Figure 11. Completed Membrane Placement.

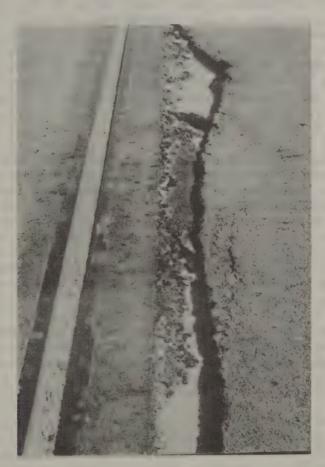
Based on reports of more serious problems a second survey was made in August 1982, approximately 10 months after reconstruction was complete. The new wearing surface in the southbound traffic lane was disbonded and sliding over the steel deck plates. The worst distress was located at each expansion joint (Figure 12) but a general displacement of the asphalt had occurred within most of the southbound area. By contrast the northbound lane showed no or only minor evidence of distress. In some of the wheelpath area the asphalt had shoved laterally, resulting in a slight depression of the bituminous material (0 to 1/8").

Figure 12. Wearing Course Failure at South Bay

The failure mode in the southbound lanes was observed to be complete disbondment between the first bituminous concrete paving course and the zinc-rich painted steel deck. This occurred at each expansion joint and resulted in the entire wearing system sliding from 12 to 18 inches away from the north, trailing side of the joint header. The painted deck was completely exposed in this area and there was no visible evidence of the asphalt emulsion tack coat on the steel surface. Accompanying this disbondment, the southbound lane had shoved laterally across its entire 12 foot width. This was observed as tearing and cracks in the top (second) bituminous paving course and bulged areas at each edge of the travel lane. A stringline placed across the southbound lane showed a typical ½ to 1 inch depression of the bituminous material. It should be noted that at the time of failure the two components of this experimental system were observed to be in good condition; the zinc-rich paint was intact and the fabric membrane well adhered to the bituminous paving courses.

A definite reason for the failure of the wearing system in the southbound travel lane at South Bay has not been determined. However, based on investigations and the comparable satisfactory performance of the northbound lane, placement of the southbound wearing system in the cooler weather conditions of October appears to be the primary cause of this problem.

It is evident from these results that both paving courses in the southbound lane had much higher air voids than the northbound side. The values given are significantly higher than the 4-8% air voids common in a field compacted mix of this type. As a result, it appears that inadequate mix compaction during cool weather resulted in an unstable mix and shoving.

Based on the results of the investigation of the South Bay wearing system failure and the satisfactory performance of the wearing system on the Webster Street Bridge, it has been recommended that South Bay be repaired using the "Bituthene 5000" wearing course system. At the present time, a contract is being prepared to initate this work in the Summer, 1984.
